Executive Summary

A total of eighty-three (83) stream visual assessments were conducted throughout the Metedeconk River watershed during spring 2010 to support the development of a watershed protection and restoration plan. The visual assessments were performed in accordance with a Visual Assessment Project Plan and assessment protocol approved by the New Jersey Department of Environmental Protection.

Stream Visual Assessment Results

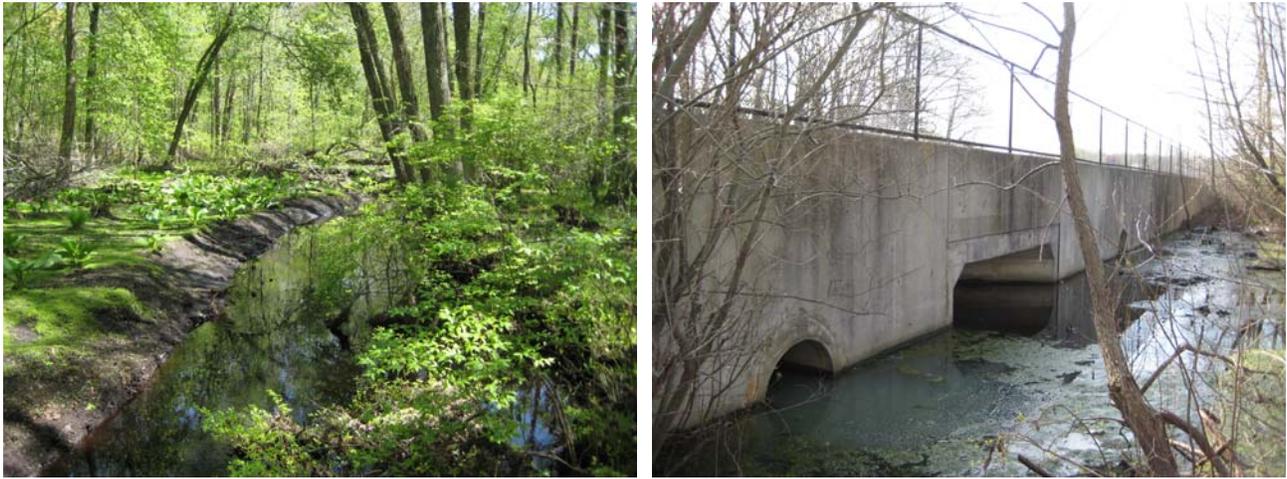
Figure 2 – Site NM (left) a high-quality headwater site and Site SHB2 (right) a degraded stream in a residential area

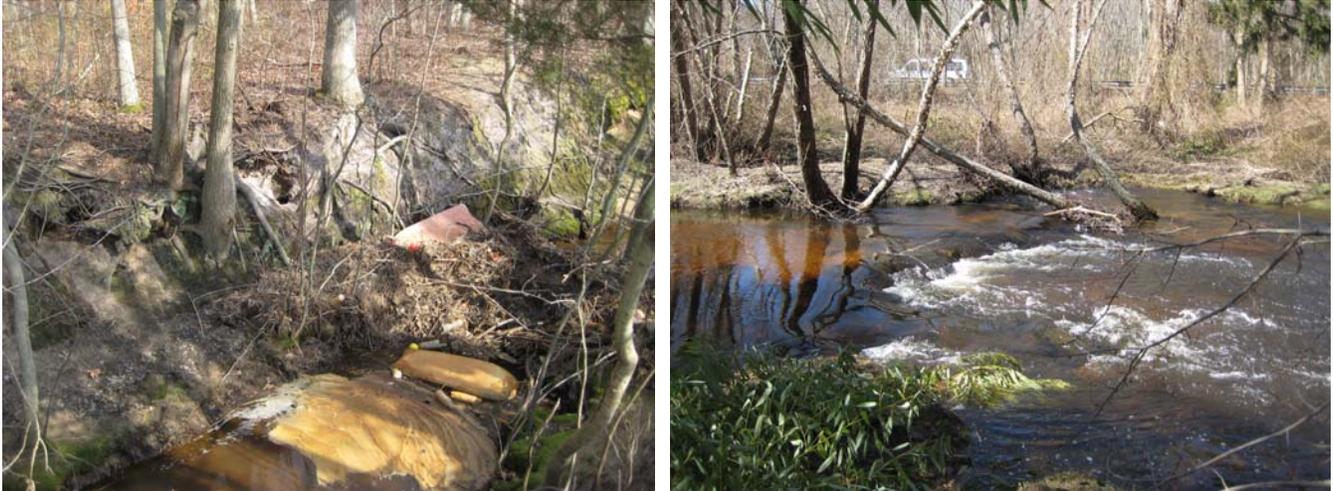
For the most part, the Metedeconk River does not suffer from severe stream erosion problems that are common in similarly developed watersheds in the region (e.g. Manasquan River). It appears that the watershed's gentle topography, sandy soils and prevalent wetlands have thus far provided some level of stability despite measurable changes in stream flow characteristics. Erosion and sedimentation problems documented during the assessments are largely confined to the smaller tributaries that receive heavy stormwater flows (Figure 6).

Figure 6 – Heavy erosion along tributary site GH1 (left) compared with minimal erosion and a functional floodplain along North Branch Metedeconk River site ND (right).

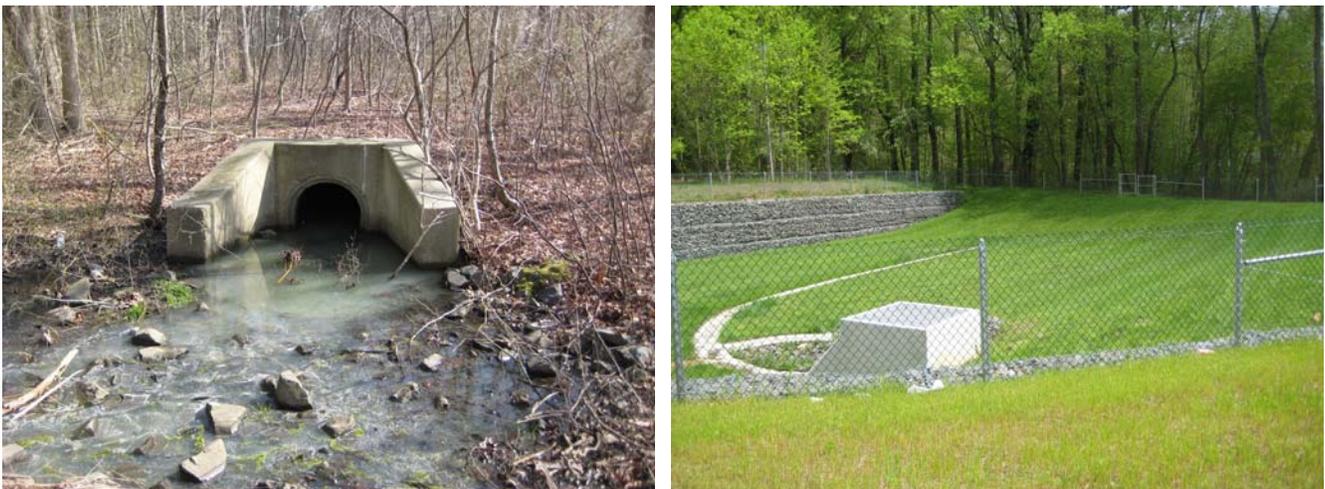
Stormwater management was a common issue documented in the assessments. Stormwater infrastructure that would be considered antiquated by today's standards is prevalent throughout the watershed. Older stormwater systems were designed to simply remove stormwater from a site, with the runoff either discharged directly to the nearest waterway or temporarily held in a detention basin prior to discharge (Figure 10). Direct stormwater discharges to the river were found at 68 sites, and a total of 117 storm outfalls and 24 drainage ditches were cataloged. Direct stormwater inputs typically present problems for Metedeconk River water quality and flow characteristics. Detention basins in varying condition were identified in close proximity to 20 assessment sites. These basins were designed to moderate runoff flows and prevent downstream flooding but do little to improve water quality or infiltrate stormwater.

Figure 10 – Direct stormwater discharge outfall from an older residential subdivision at site TUR2 (left) and a detention basin adjacent site TR13-1 (right)

There is considerable opportunity in the watershed to retrofit existing infrastructure with stormwater best management practices (BMP's) which would reduce nonpoint source pollutant loading, enhance groundwater recharge, and help restore a more natural hydrologic function to existing developed areas. The assessments documented 49 sites (59 % of the sites evaluated) where installation of stormwater BMP's or the retrofit of basins appears feasible and beneficial. Targeted BMP retrofit projects would effectively complement the activities required under New Jersey's stormwater management regulations to reduce nonpoint source pollution.

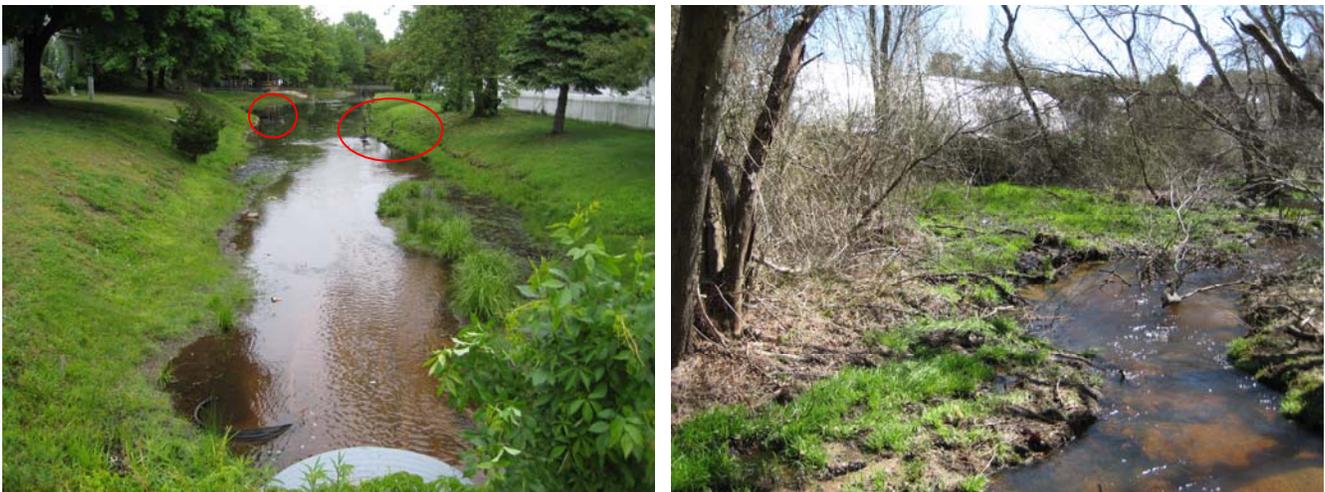
Figure 11 – Geese in the stream and on the banks at site TR21-2 (left) and unusually lush vegetative growth fueled by runoff from a nursery at site SHB1 (right).

SHB1							X	X	X				There is potentially some opportunity to improve the riparian buffers in this area; it appears nutrient-laden runoff is entering the stream from the adjacent nursery and causing unusually lush vegetative growth on the bank - agricultural BMP's would be prudent; reach is adjacent WDI Landfill; an artesian well is located at the residence on the left bank
SHB2	X	X		X	X		X					X	Stormwater BMP's possible for sports complex and parking lots as well as throughout residential subdivision; numerous detention basins throughout subdivision would be good candidates for retrofit; possibly some opportunity to expand riparian buffer area; dense algae growth along reach (indicative of nutrient loading?); dump area near reach (appliances; tanks; etc.)
SI	X						X			X	X		Lake Eno is immediately upstream of the reach - there is some opportunity to restore riparian/lakeshore vegetated buffer area along Bennetts Mills Rd; the lake is shallow, appears eutrophic and contains nuisance (likely invasive) aquatic plants - lake management/restoration would be beneficial; numerous waterfowl observed in the lake

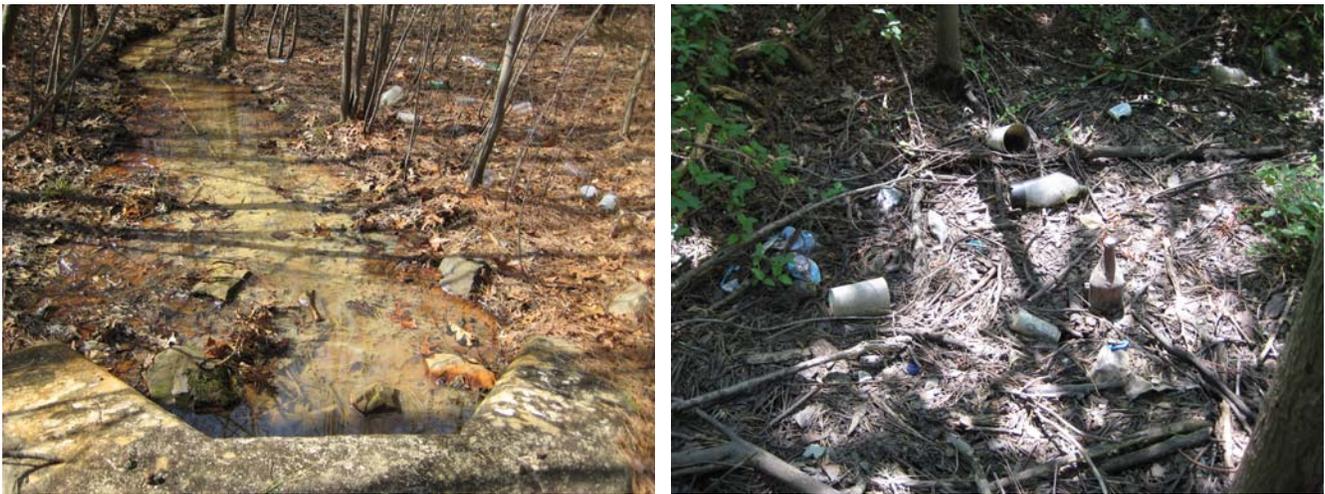
An exorbitant amount of trash, mostly floatable debris, was observed during the assessments (Figure 12). Floatables do not necessarily impact water quality but can pose a hazard to wildlife. Further, their presence undermines the aesthetic qualities that are important to recreational uses and suggests a human disregard for local water resources. Perhaps most importantly, floatables serve as a clearly discernible sign of the impact that stormwater runoff is having on the Metedeconk River and its tributaries and can be an indicator of flashy or high stormwater flows. The retrofit of older storm grates, which is occurring to some extent as a result of New Jersey's stormwater management regulations, would help prevent floatables from entering waterways (Figure 13). Dumping was also a concern in the watershed (Figure 14). Dumping of yard waste or other vegetative debris was encountered at

Figure 12 – Floatable debris at sites TUR2 (left) and CBB-1 (right)

CBB-1	X	X	X	X	X	X	X		X			X	Stormwater BMP's would reduce NPS/runoff volumes from large commercial area; some storm infrastructure requires maintenance; basins are possible candidates for retrofit; opportunity for restoration of unstable banks; some potential for riparian buffer restoration along portion of reach; lots of garbage/debris; poor housekeeping behind shopping center to north; illicit dumping of cooking grease discovered and reported; old landfill exists along reach
CBB-3	X	X	X		X							X	Stormwater BMP's would reduce NPS/runoff volumes from large commercial area; some storm infrastructure requires maintenance; floatable garbage/debris; much of the reach is culvert
CBB-5	X	X		X									There are stormwater discharges both upstream and downstream of the reach; area around reach is part of Lakewood Industrial Park and has lots of impervious cover - there are opportunities for stormwater BMP's and basin retrofits to address NPS pollution and runoff volumes along reach and throughout the general area

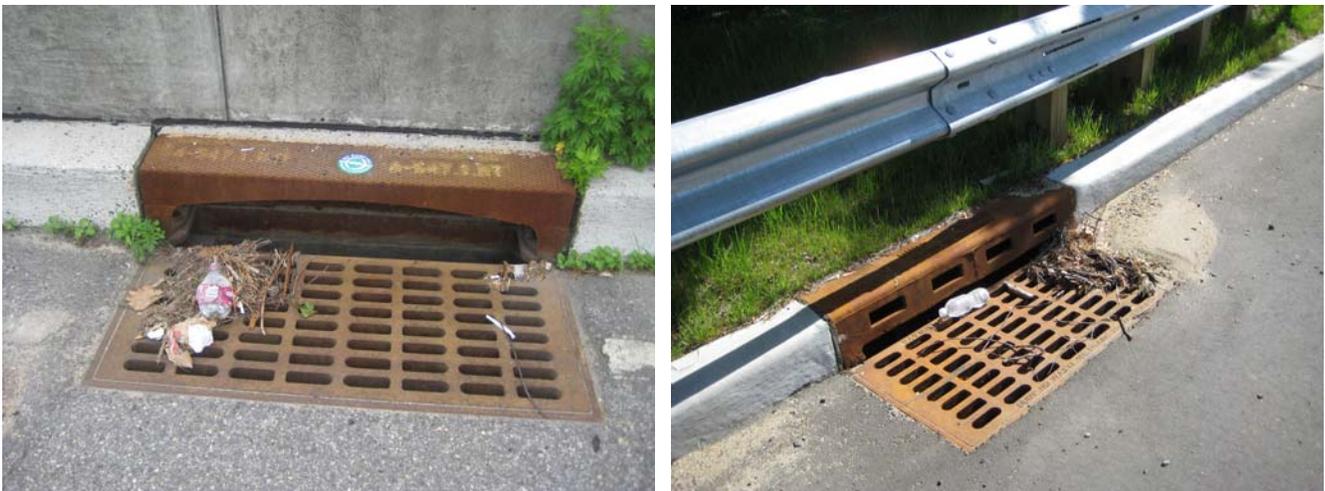
Figure 13 – An older style storm inlet grate at site NE (left) and a newer style grate designed to prevent passage of floatable debris at site TR10 (right)

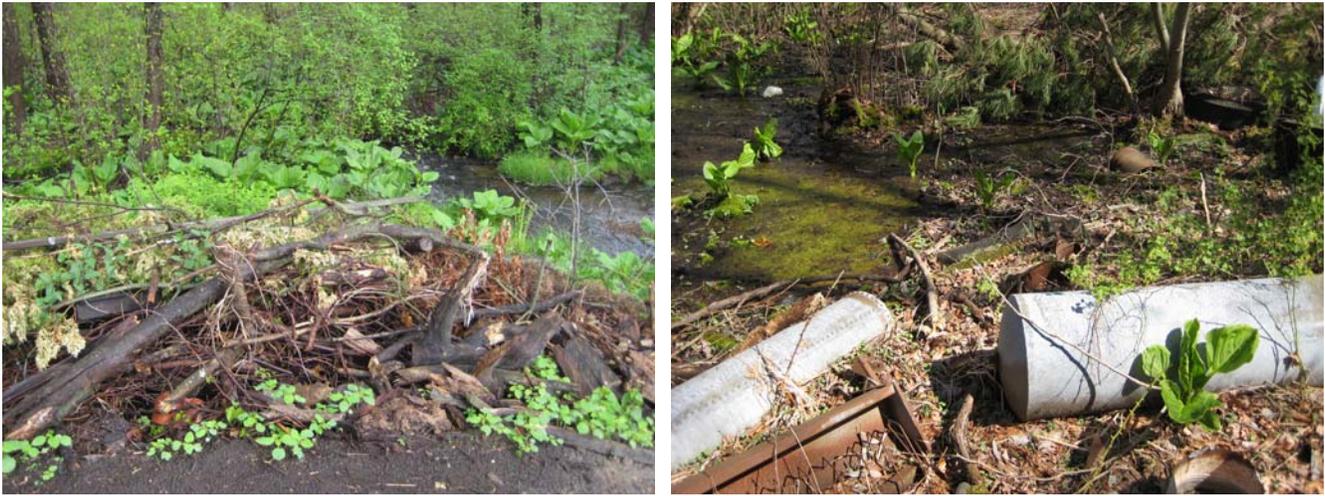
numerous sites during the assessments. In several cases, dumping of other types of material was documented, including building materials, old appliances, scrap metal, oil tanks, tires, shopping carts, bicycles and children's toys. Poor housekeeping was also identified at a few commercial facilities that border streams in the watershed.

Figure 14 – Dumping of leaves, grass clippings and larger yard waste at site TR12 (left) and appliances, water tanks and other debris at site SHB2 (right)
