Executive Summary

A total of eighty-three (83) stream visual assessments were conducted throughout the Metedeconk River watershed during spring 2010 to support the development of a watershed protection and restoration plan. The visual assessments were performed in accordance with a Visual Assessment Project Plan and assessment protocol approved by the New Jersey Department of Environmental Protection.

Stream Visual Assessment Results

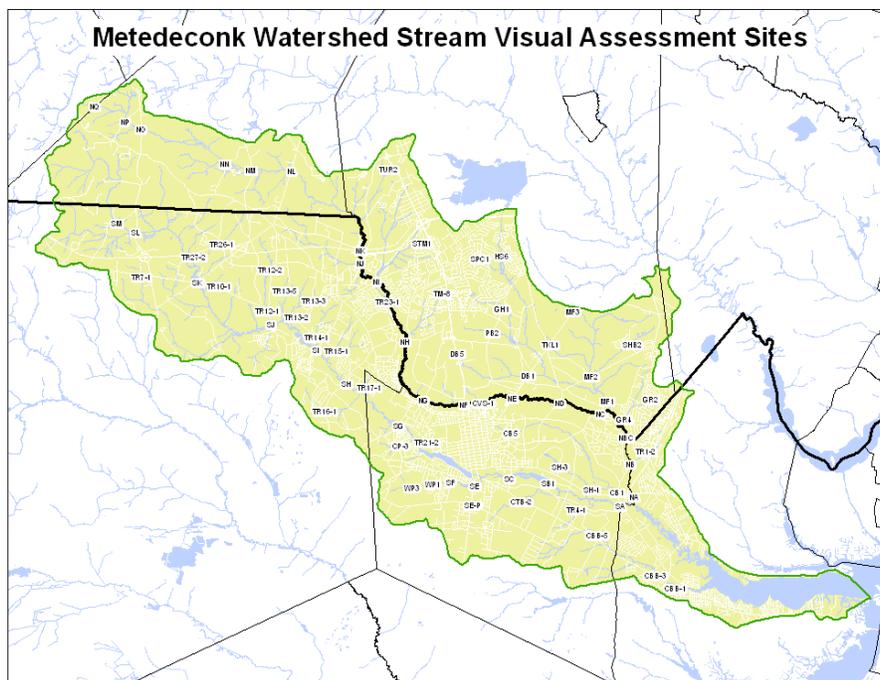
Figure 1

A total of eighty-three (83) stream visual assessments were conducted throughout the Metedeconk watershed during winter and spring 2010 (Figure 1). The stream reaches were selected to be representative of the watershed and encompass a broad range of conditions, from forested headwater areas to heavily urbanized commercial centers closer to the coastline (Figure 2). The reaches varied in length depending on size of the stream channel and site conditions, and ranged from 129 feet to 3,650 feet with a median length of 480 feet. The assessment data includes 1,762 digital photographs and 914 GPS positions of important watershed features.

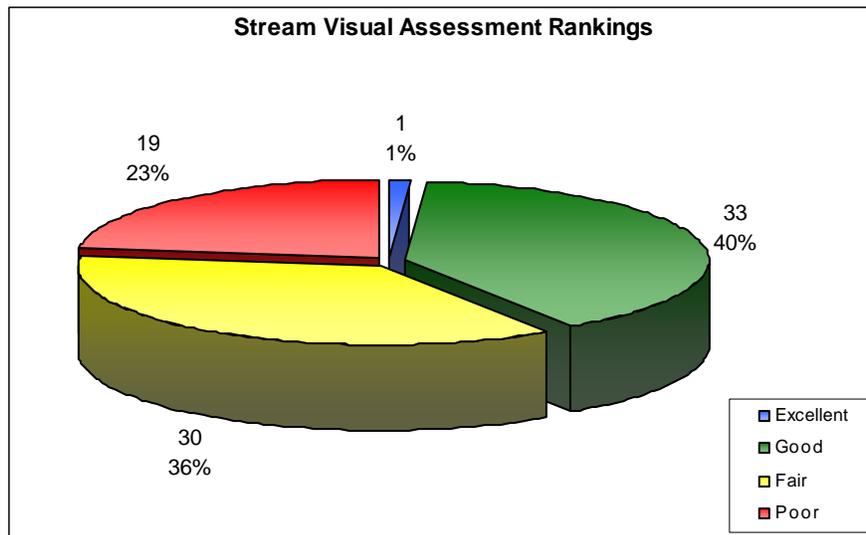
Figure 3

Based upon the scores, the assessment reaches were categorized as Excellent (≥ 9.0), Good (7.5-8.9), Fair (6.1-7.4), or Poor (≤ 6.0). A breakdown of the scores is presented in Figure 3. Of the 83 visual assessments conducted, one (1) site ranked Excellent, thirty-three (33) ranked Good, thirty (30) ranked Fair, and nineteen (19) ranked Poor. In terms of percentages, 1% ranked Excellent, 40% ranked as Good, 36% ranked as Fair, and 23% ranked Poor. The geographic distribution of the assessment site rankings is shown in Figure 4. Using these same categories and the overall mean and median reach scores from Table 2, the watershed as a whole ranks as Fair.

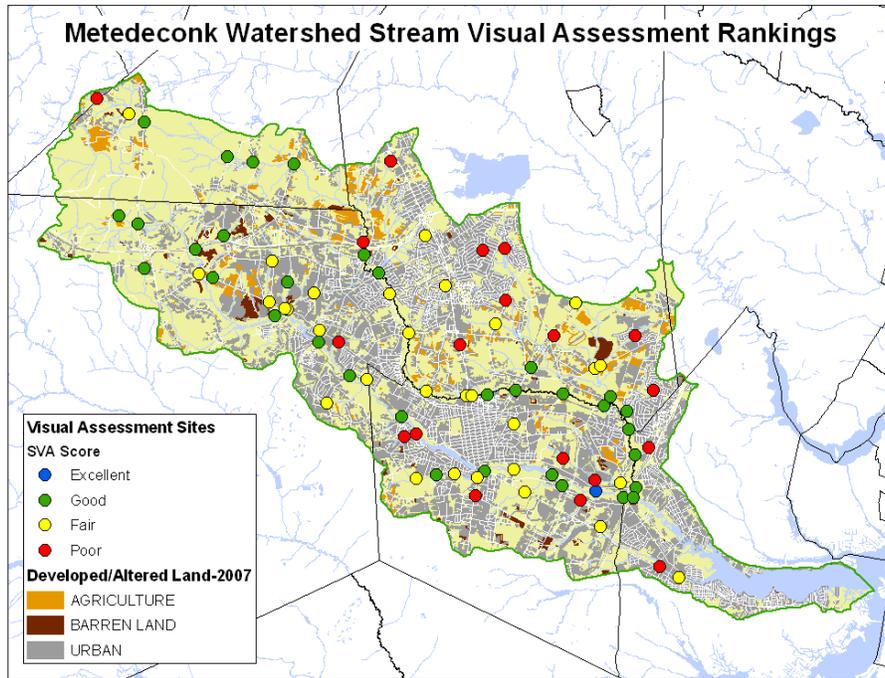
Figure 7

As one would expect, streams in more urbanized areas tended to exhibit greater impairment and receive lower assessment scores, and vice versa. It appears from the assessment results that the higher-order streams (e.g. the north and south branches) maintain greater resilience to the effects of local urbanization than the lower-order streams (e.g. smaller tributaries). The lower-order streams with the lowest scores were in medium-density residential developments and, in these cases, the stream has in effect become part of the stormwater conveyance system. However, even minor alterations along the lower-order streams from their natural state were enough to cause lower assessment scores. Assessment indicators related to in-stream habitat (e.g. pools, in-stream fish cover and invertebrate habitat) appear to be the most sensitive to changes in stream condition and the first indicators of impaired stream health. A map of the assessment sites along with land cover categories associated with disturbance (i.e. urban, agriculture and barren lands) is shown in Figure 7.

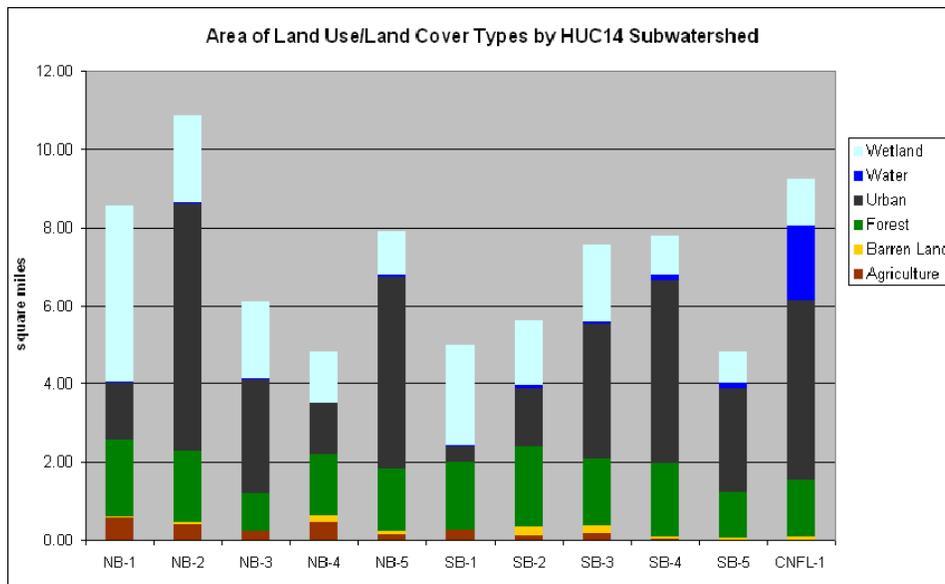
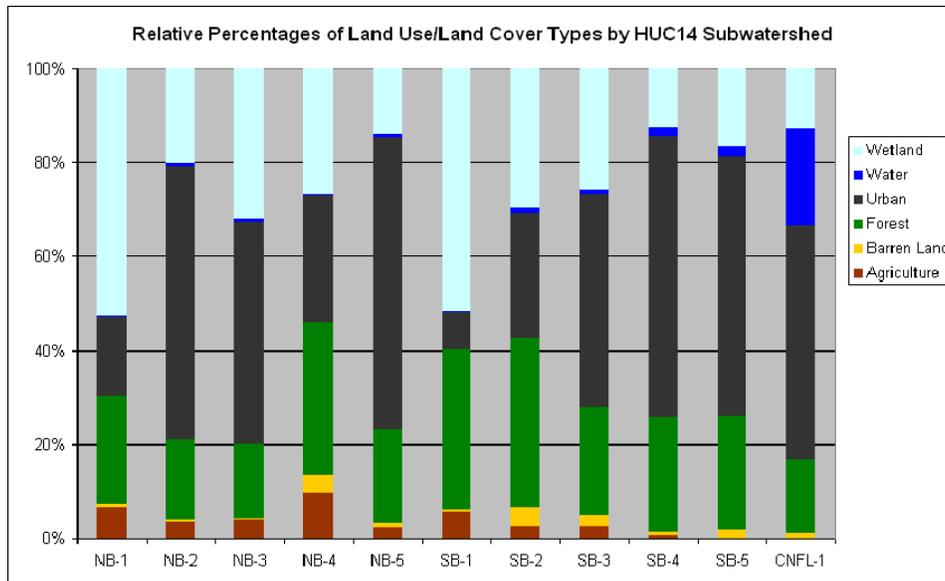
An analysis of the assessment data by HUC14 subwatershed provides further insight into the relationship between land use and stream health. Figure 8 shows the relative areal coverage of each landuse/landcover type by HUC14. Figure 9 shows a GIS classification (using Jenks natural breaks optimization) of HUC14 average assessment scores into five classes.

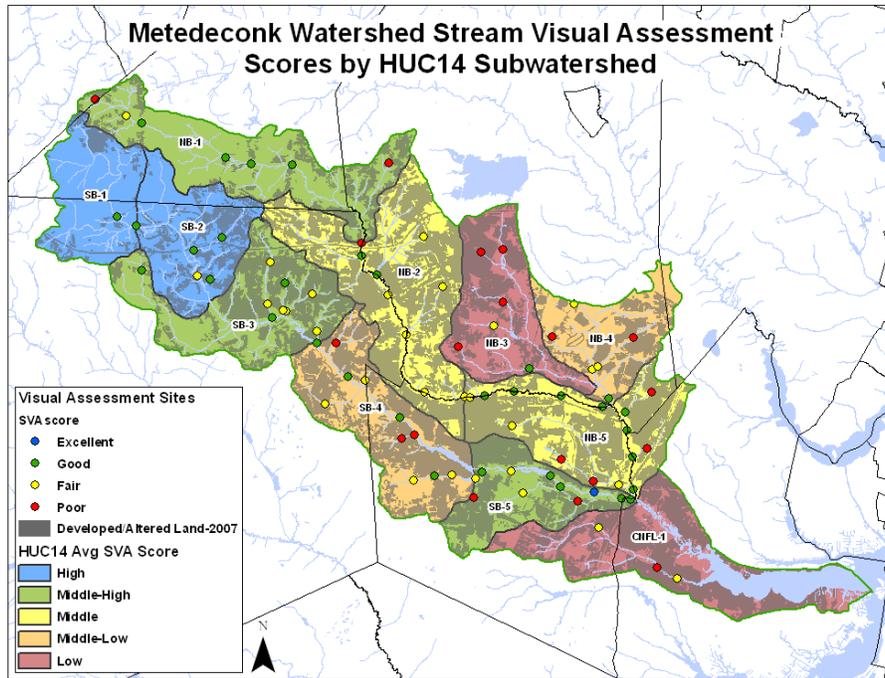
It is evident in Figure 9 that there is a general progression of higher to lower assessment scores from the relatively undeveloped headwaters in the western areas of the watershed to the more densely developed areas in the east. SB-1 and SB-2 are relatively undisturbed HUC14's and ranked in the highest class. NB-1 is similar to SB-1 and SB-2 in terms of land use and stream reach condition but also includes two sites along major transportation corridors (County 537 and State Highway 9) that scored poorly and brought down the average enough to place it in the middle-high class. The subwatersheds NB-3 and NB-4 drain a sizable portion of Howell Township along Hay Stack Brook and Muddy Ford Brook to a single point along the North Branch. These HUC14's are somewhat rural in nature, though NB-3 is more urbanized than NB-4. NB-3's headwaters have been affected by residential development and the Route 9 corridor, giving it the lowest average score of all the subwatersheds. NB-4 has headwaters in agricultural and low-density or rural residential areas. The lower classifications for both NB-3 and NB-4 can be attributed to the more sensitive nature of the smaller streams in this area to local land disturbance. SB-5 stands out because it ranks in the medium-high class despite being located along the Route 9 corridor in a heavily urbanized area of Lakewood Township. However, this HUC14 is also characterized by a riparian corridor that has been left intact and large contiguous areas of open space, including two Ocean County parks. Lakes Carasaljo and Manetta immediately upstream may also have a role in moderating South Branch flows entering SB-5. CNFL-1 is heavily urbanized and ranked in the lowest class, though it should be noted that stream assessments in this HUC14 were limited to the Cedar Bridge Branch due to the tidal influences on the Metedeconk River.
